**DEPARTMENT OF TRANSPORTATION**

Contract #: 04-0120F4Cty: SF/ALA Rte: 80 PM: 13.2/13.9File #: 69.28**WELDING INSPECTION REPORT****Resident Engineer:**Pursell, Gary**Address:** 333 Burma Road**City:** Oakland, CA 94607**Report No:** WIR-015078**Date Inspected:** 22-Jun-2010**Project Name:** SAS Superstructure**OSM Arrival Time:** 700**Prime Contractor:** American Bridge/Fluor Enterprises, a JV**OSM Departure Time:** 1900**Contractor:** Zhenhua Port Machinery Company, Ltd (ZPMC), Changxing Island **Location:** Shanghai, China**CWI Name:****CWI Present:****Yes No****Inspected CWI report:** **Yes No N/A****Rod Oven in Use:** **Yes No N/A****Electrode to specification:** **Yes No N/A****Weld Procedures Followed:** **Yes No N/A****Qualified Welders:** **Yes No N/A****Verified Joint Fit-up:** **Yes No N/A****Approved Drawings:** **Yes No N/A****Approved WPS:** **Yes No N/A****Delayed / Cancelled:** **Yes No N/A****Bridge No:** 34-0006**Component:** OBG Trial Assembly**Summary of Items Observed:**

Orthotropic Box Girder (OBG) Trial Assembly Areas

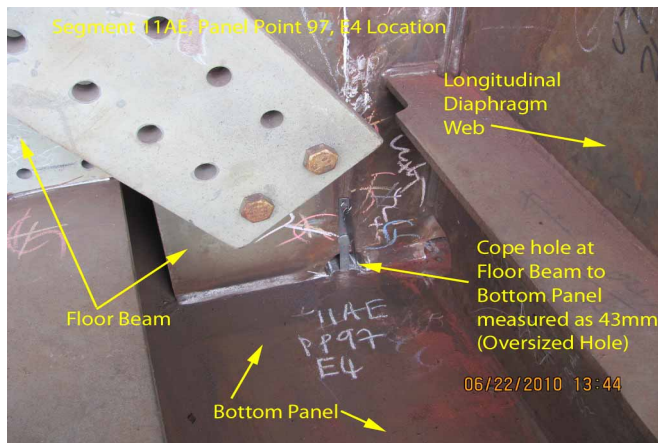
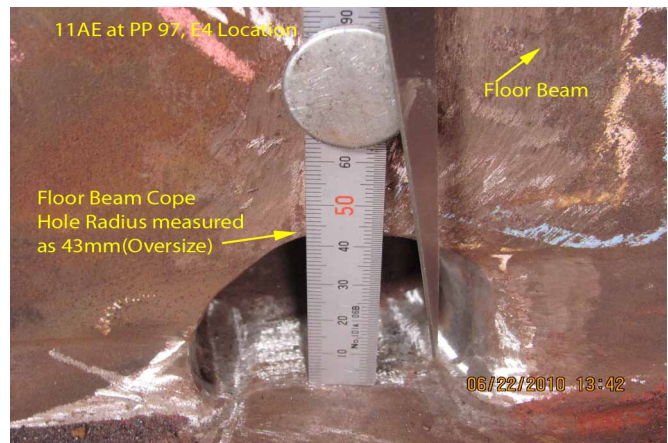
This QA Inspector performed Dimension Control Inspection for the Floor Beam to Bottom Panel Cope Holes and Floor Beam to Side Panel Cope Hole at Work Point E4 and E3 at Panel Point (PP) 95, PP 96 and PP 97 for Segment 11AE the Inspection was performed against the ABF Inspection Report No. CWAHIR-11AE-01 Dated June 21, 2010. The measured readings were recorded in the Dimension Control Form (DCP) and submitted to the Task Leader and Engineer for review. Please refer the pictures attached for more comprehensive details.
